British Precast Drainage Association

HDPE Pipes and Progressive Deformation: Case studies from Kentucky and Ohio, USA

Kentucky DoT Inspection and Progressive Deformation

Further Evidence: Ohio DoT Investigation

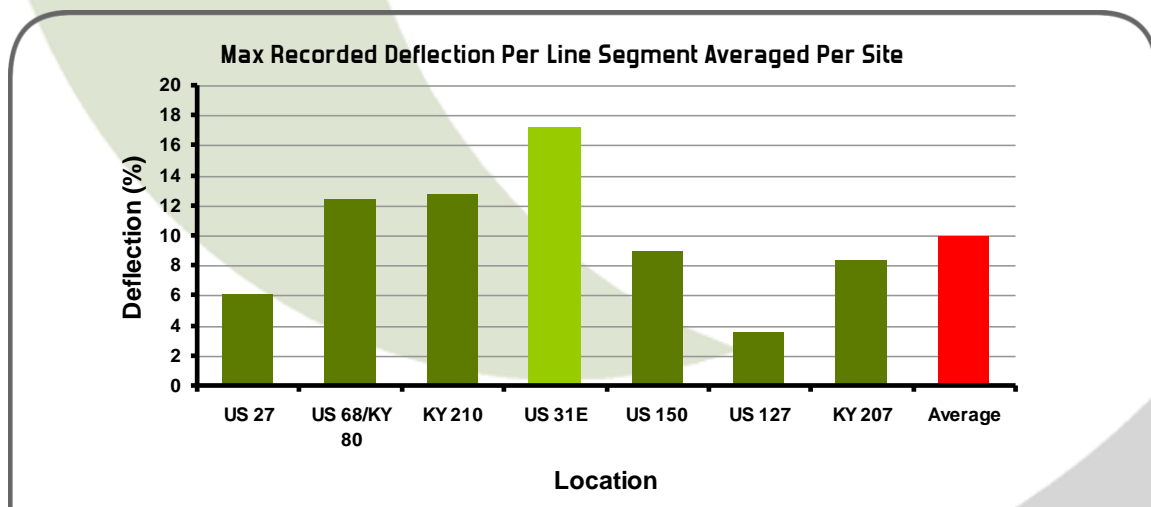
- At one site (Site 1) the inspection showed indications that several segments within a pipeline (last inspected in late 1991 with no deformations exceeding 5%) have experienced significant deflections exceeding 5%, with one location approaching 10%¹. At another site (Site 2) average deformation was between 5 to 10%, with one pipe deflecting by 14%, that same pipe was inspected three years earlier and was found at the time to be deformed by 11%.

- The same pattern was observed in another site (Site 7) where an earlier 1991 inspection showed maximum deformation at some sections at 5.5 and 7.3%. The 2005 inspection showed that deformation at the outfall line has increased to 10 and 12%, raising numerous questions about the actual service life of these pipeline systems. Two other pipeline sites (Sites 3 and 4) experienced severe deflections with 10 to 13% for the first site and 50% (a collapsed storm pipeline) for the other. A third site (Site 5) showed several deformations reaching 10%.

Figure 1. Maximum recorded deflection per line segment averaged per site inspected by Kentucky DoT.

- The final study report noted that the majority of pipes investigated at this project would not pass a 5% deformation requirement and most of the sites included have pipe sections that would not pass a 10% deformation test. It is noted in the complete report that several of the pipes have continued to deform since initial installation. It is also evident that the HDPE pipes are sensitive to construction installation and proper care is needed to ensure good performance. According to the report it is apparent that cracking and deflection had continued to occur in some of these sites since that 2005 inspection.

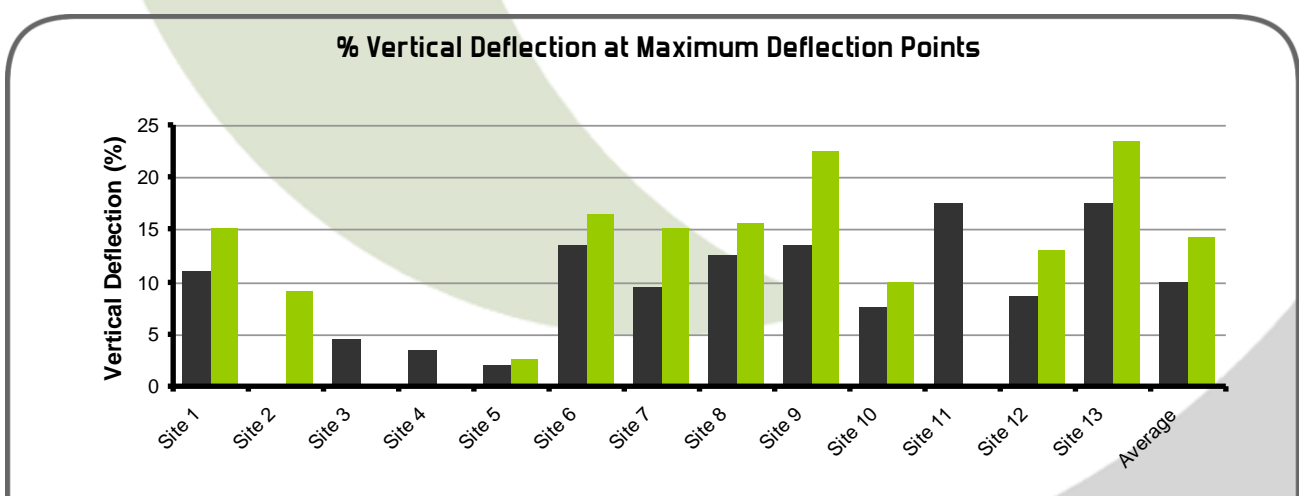
- In Site 1 manual deformation measurements taken in 2005 indicates that a 36inch (Approx DN900) drain pipe installed in 1992 continued to deform: from a maximum deformation in 2001 of 11.81% to a maximum of 15.63% in 2005. Approximately 23% of the vertical measurements taken in 2001 would not pass a 5% deformation test, this has increased to around 43% in 2005. At another site with 60% of vertical readings for a 48inch (Approx DN1200) 21 metre long drain pipe did not pass a 5% deflection test, indications showed that this percentage has increased to 87% in 2005. At the same site the greatest deformation taken moved from 14.84% in 2001 to 17% in 2005. The same pattern was also documented at sites 7, 8, 9, 10, 12, and 13. More worryingly, at site 8 deterioration was not restricted to excessively deformed pipe sections, at the site two thirds of vertical deformations exceeded 5% in 2001, in 2005 it was found that 71% of deformations were over 5%. Site 10 showed an even faster pace with 9% of readings exceeding 7% deformation in 2001, increasing to 45% of reading in 2005.

- The problems at these sites were not restricted to deformation, The pipes suffered from problems with cracking, cross drains inspected for this project showed that cracking has increased by four to seven times since the 2001 inspection. There were also other problems with bulging, sagging, and problems with joints and connections.

Figure 2. Vertical Deflection at Maximum Points in 13 Ohio Site in 2001 (in Grey) and 2005 (in Green).

- The majority of pipes investigated at this project would not pass a 5% deformation test and most of the sites have pipe sections that would not pass a 10% deformation test. The majority of pipes have continued to creep and deform since the 2001 inspection. There were indications that in at least two sites the problems of deformation may have been caused by faulty installation.
