A Message from the American Concrete Pipe Association

Bulletin No. 134

What Positive Lessons can be Learned from an HDPE Fire?

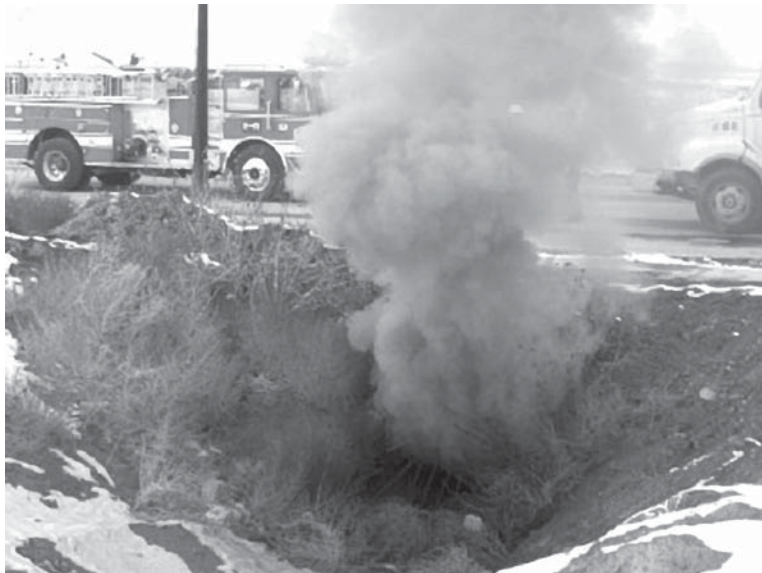
Smoke pours out of 42" HDPE storm drain after catching fire.

The storm drain flowed down an incline with the start of the fire at the lowest point in the pipe. Much like a forest fire spreads upslope, this fire moved rapidly up the pipe, burning the invert of the pipe and melting the

worker attempted to cut off the fire by cutting through the pipe with a backhoe, but he was too late. The pipe had already burned and partially collapsed as soon as the backhoe was over it. City Council members helped send water from fire hydrants down the storm drain, but by then over 800 feet of the 42" HDPE pipe was lost. The cost to reconstruct the storm drain with a more durable reinforced concrete pipe was nearly \$30,000 and had to be accomplished rapidly since this important drainage could not be left out of service. The City was fortunate that the pipe was in an area where roadway replacement was not necessary.
