British Precast Drainage Association

Fires in Sewers and Culverts

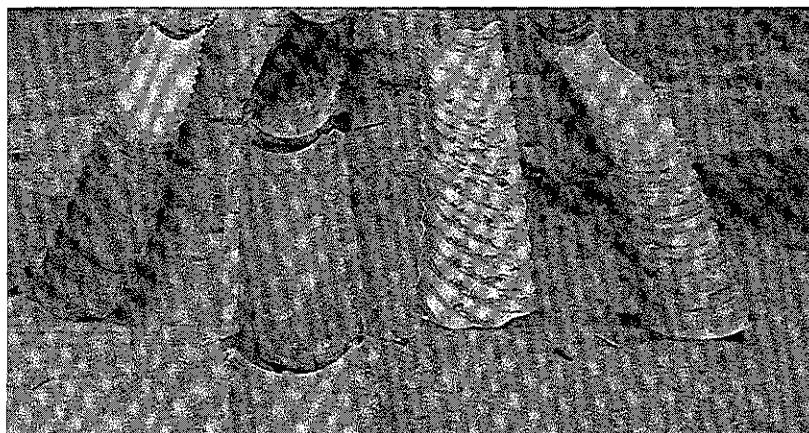
Test sections of (left to right) corrugated steel pipe with asphalt lining and coating, reinforced concrete pipe, corrugated aluminum pipe and corrugated steel pipe with polymeric lining and coating after removal from tunnel.

There was no ignition or smoke generation of the concrete during the test. Upon completion of the test and removal from the tunnel, it was observed that the first four foot section of pipe was slightly darkened and had a network of surface checking on the inside surface as a result of rapid heating. The remaining 20 feet of pipe appeared sound and no checking or spalling was apparent.

The asphalt on this material proved to be highly flammable, producing a flamespread value of 80 and a smoke density factor of 860. The asphalt lining and coating melted and dripped to the tunnel floor and burned long after the gas burners were shut down. All of the asphalt was consumed and the pipe sagged about 6 inches in the first section.

The lining on this sample, a PVC formulation, ignited just 17 seconds into the test and produced a flamespread value of 35 and a smoke density factor of 580. The lining was consumed for 14 feet and scorched the remaining 10 feet.

There was no ignition of the aluminum during the test, but smoke was observed, resulting in a smoke density factor of 35. The first section of pipe sagged, and several areas melted within 3 feet of the flame source.

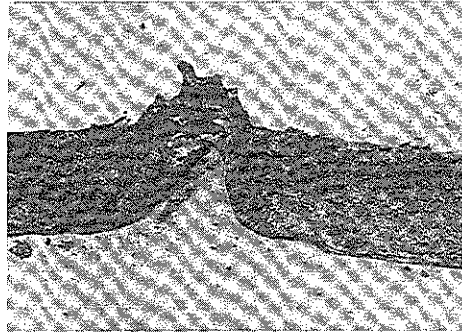
The solid wall PVC burned differently from the ribbed PVC in that it ignited more quickly and produced much more smoke. Flamespread and smoke density values were 20 and 330, respectively. This sample also collapsed to the floor after 2 minutes, 10 seconds.

Test section of PVC pipe after testing, deformation caused by brick supporting test section.

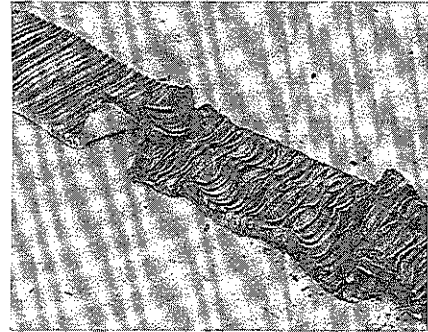
The PVC ignited in 52 seconds and produced a flamespread value of 10 and a smoke density factor of 10. After 2 minutes under flame, the sample was sagging to the tunnel floor in one area, and, at 5 minutes, the entire section had collapsed.

Ribbed PVC sewer pipe test section after test was completed.

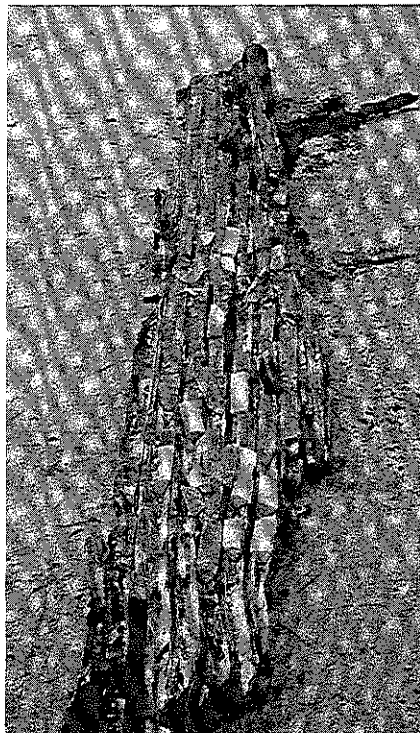
This pipe material burned rapidly and totally, leaving little more than the lightweight concrete filler after

the test was completed. The high flamespread value of 260 is attributable to the tremendous fuel capacity of the ABS in this sample. Smoke density was also substantial at 435.

ABS composite pipe section after testing.
