Concrete Pipeline Systems

Testing of pipe materials' resistance to high-pressure water jetting (Report 1)

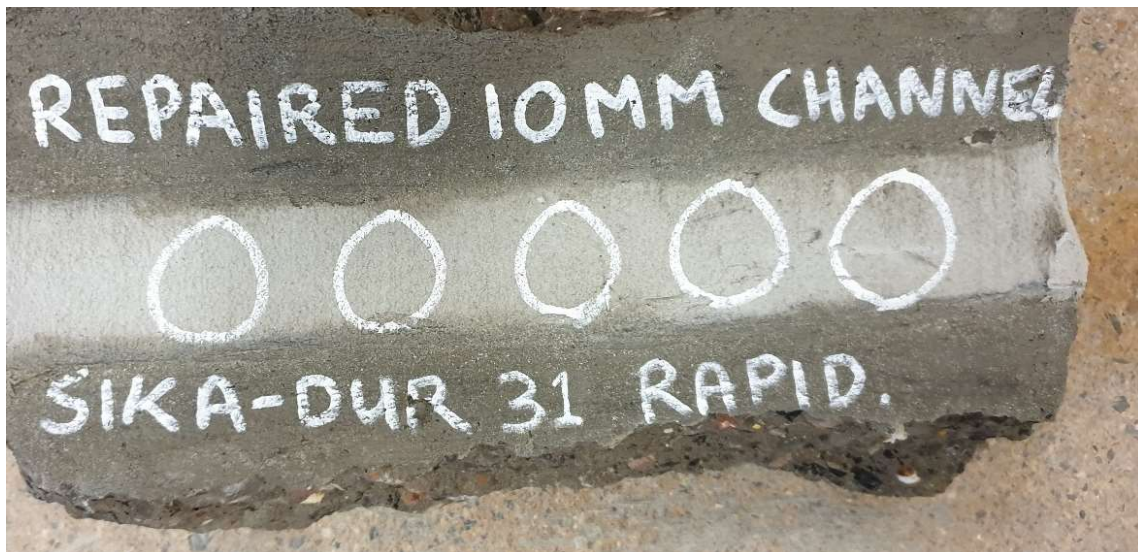
Figure 2. Sample 2 after testing.

A BPDA member company DN 450 concrete pipe with a repaired 10mm deep x 10mm wide channel¹ was tested. No visible damage was caused by the water jet at any of the jetting sites tested.

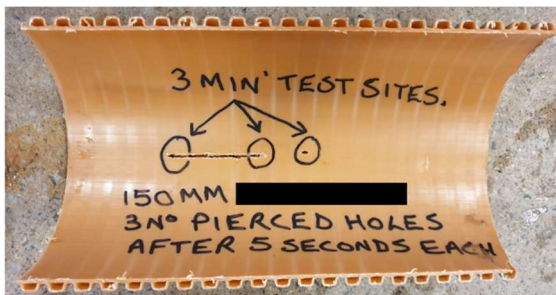
Figure 4. Sample 4 after testing.

One Double-wall type DN150 plastic pipe was tested. All three jetting test sites pierced the inner surface after 5 seconds and quickly continued to pierce through the full wall depth.

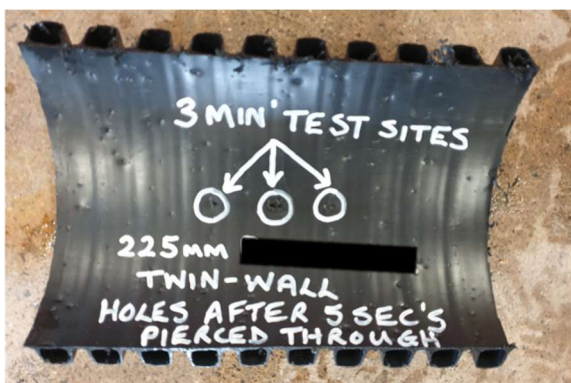
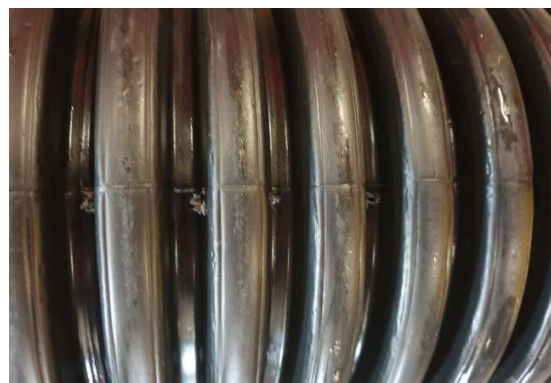
Figure 5. Sample 5 after testing.

One double-wall type DN225 pipe was tested. All three jetting sites tested pierced the full wall depth of the product after approximately 5 seconds.

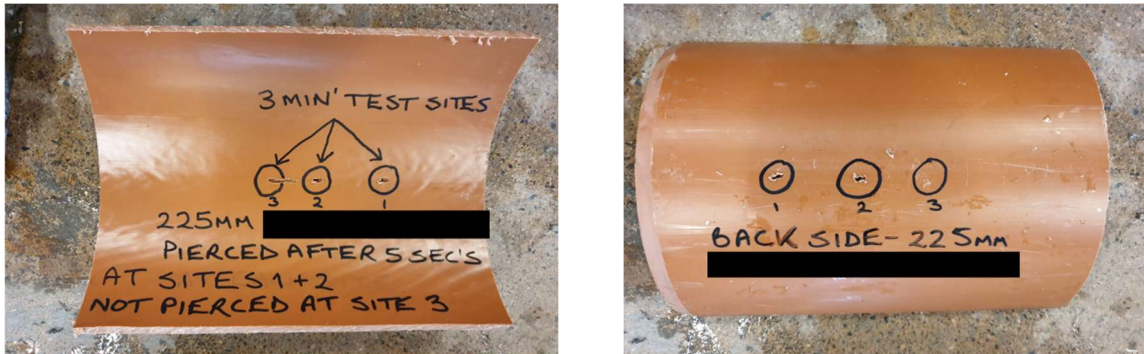
Figure 6. Sample 6 after testing.

PVC pipe with smooth external & internal surface was tested. All three jetting sites tested pierced the inner surface after approximately 5 seconds and two out of the three sites pierced the full wall depth of the product a few seconds after.
