British Precast Drainage Association

CASE STUDY FROM USA:

WHO IS LIABLE FOR FLEXIBLE PIPE PROBLEMS? THINGS TO CONSIDER

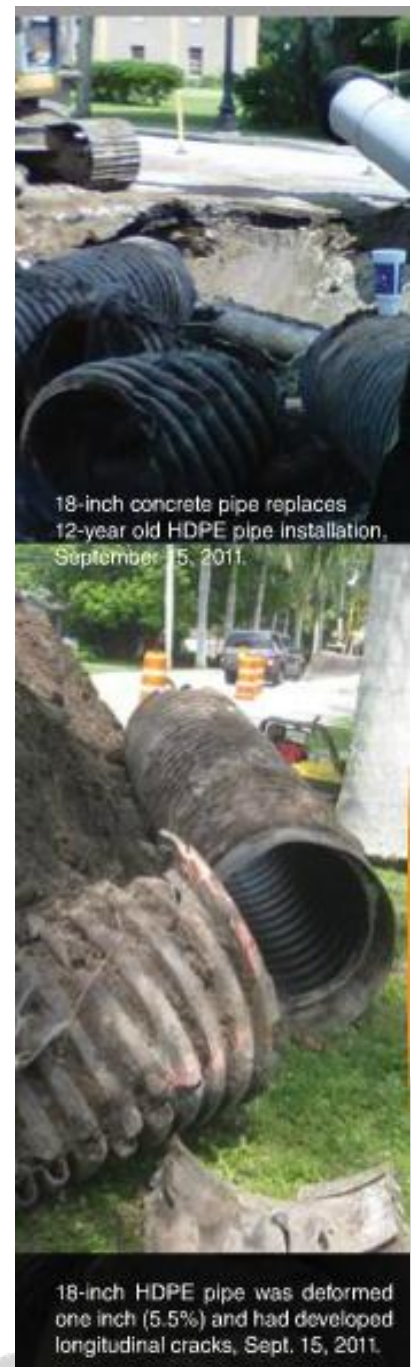
On September 21, 2012, a sinkhole formed on McGregor Boulevard at Olmeda Way in Fort Myers, Florida revealing a collapsed 30-inch (762 mm) diameter, Type S wall HDPE storm pipe. This was around one year after a similar failure for another HDPE storm sewer pipe (18-inch diameter) along the same boulevard. Both failed pipes were only installed 12 years earlier by the Florida Department of Transportation. Samples of the failed 18-inch and 30-inch HDPE pipes showed signs of longitudinal cracking through the walls along the invert and crown. Longitudinal cracks traversed the springline of the outer corrugation. The HDPE material of both failed pipes appeared brittle and the corrugations and bell could be easily manipulated by hand, suggesting the pipe's initial material properties may have diminished¹.
