British Precast Drainage Association

The Real Scale of Plastic Pipes' Deformation? A US Case Study.

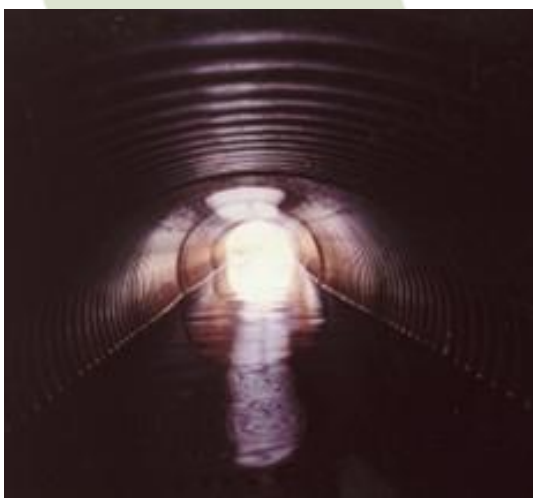
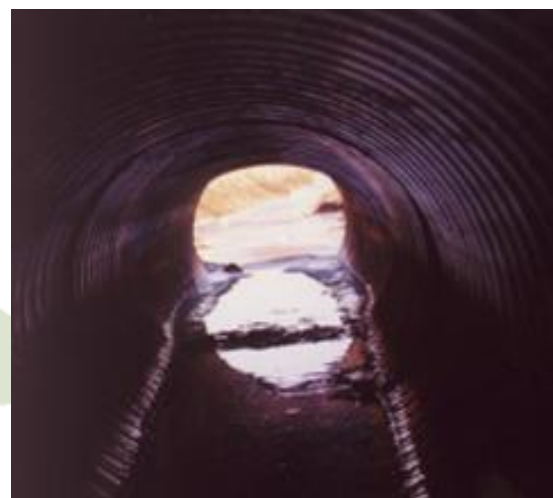
Figure 1. Two Cases of plastic pipe deformation from the survey carried out in six American States. Report by Wiss, Janney, Elstner Associates (2002)

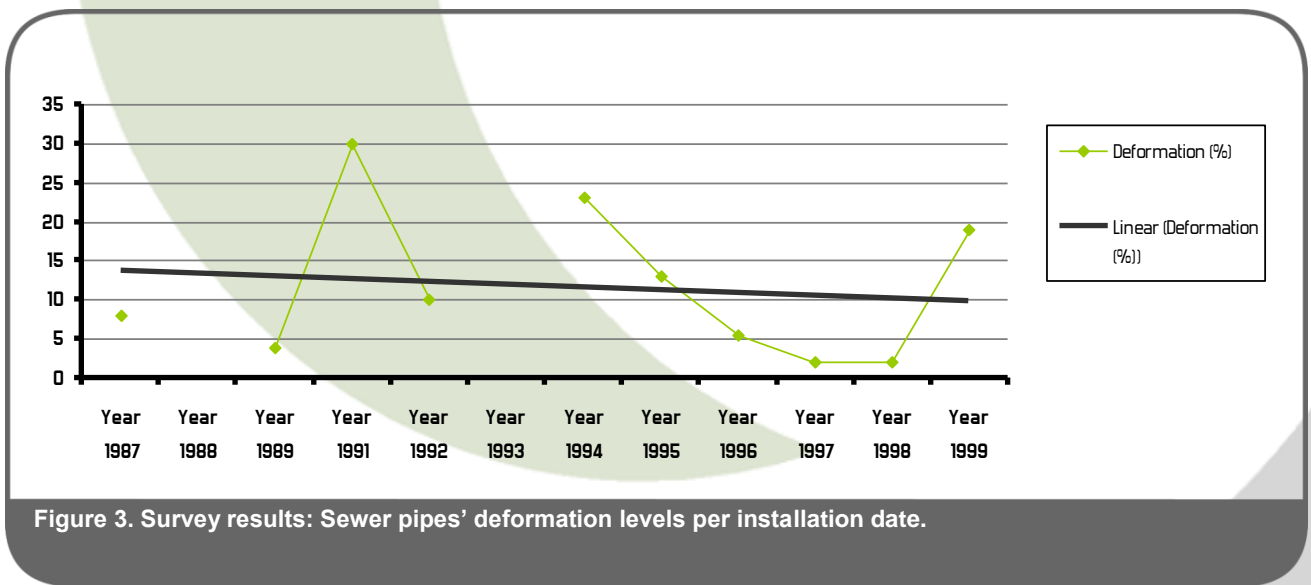
- **Pipe Age:** The pipelines considered in the survey were installed between 1987 and 1999. It is still possible to detect a pattern that shows a link between increase/progression of pipe deflection and date of installation of pipe. The trend line is not strong enough due to the small sample considered in the study and the fact that other stronger factors, contributing to deformation, may have prevailed.

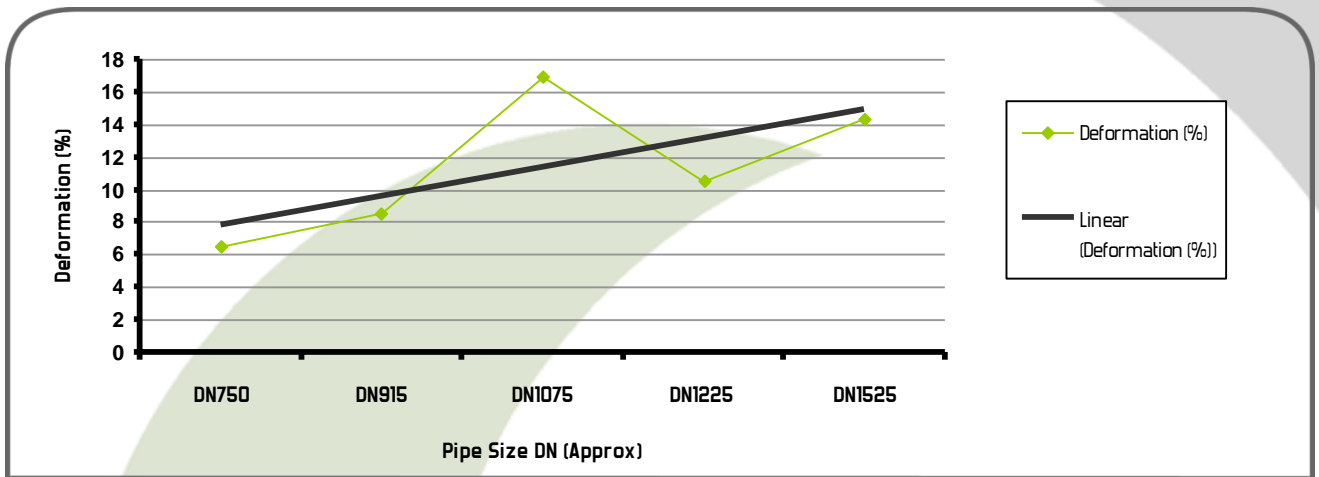
Figure 4. Survey Results: Sewer pipes' deformation levels per size (internal diameter).

- **Pipe Diameter:** The link between deformation and pipe diameter was stronger. However, this does not necessarily mean that diameter is the main factor associated with deflections as the sample was considerably small and one pipe diameter category (54 inch or DN 1375) was eliminated as there was only one pipe with such size.

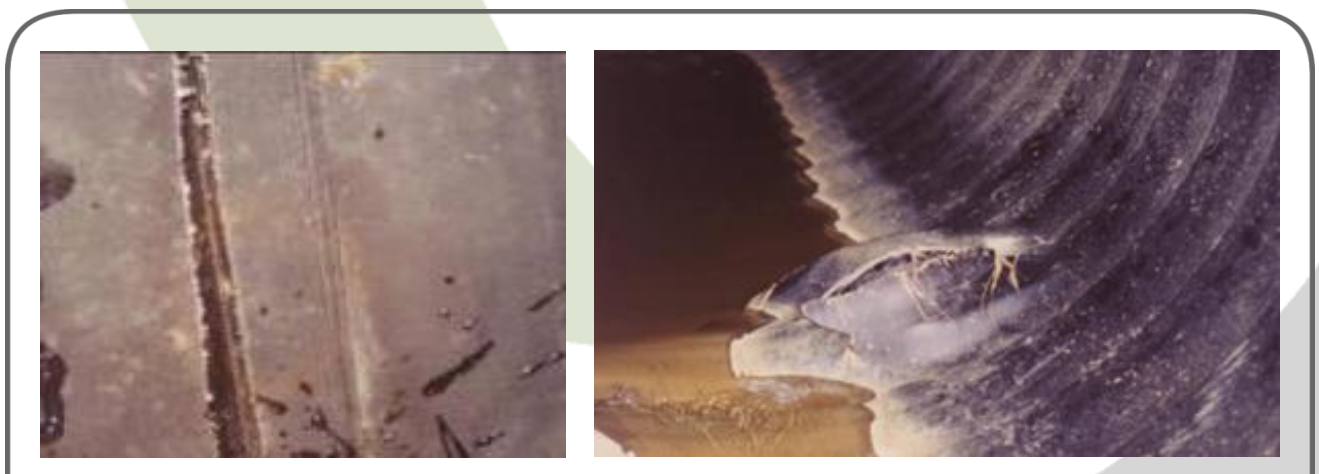
Figure 5. Cases of plastic pipe bulges and cracks from the survey (2002)

Another alarming finding is the significant level of cracks, bulges, and buckling in the pipes: out of 39 pipelines inspected, 24 pipes had problems with cracking, bulging and buckling. Ultimate collapse scenarios have been linked with cracks as well as deformation in different studies in the past, however this study did not investigate these possible links.
