What do you know about plastic pipe deformation?

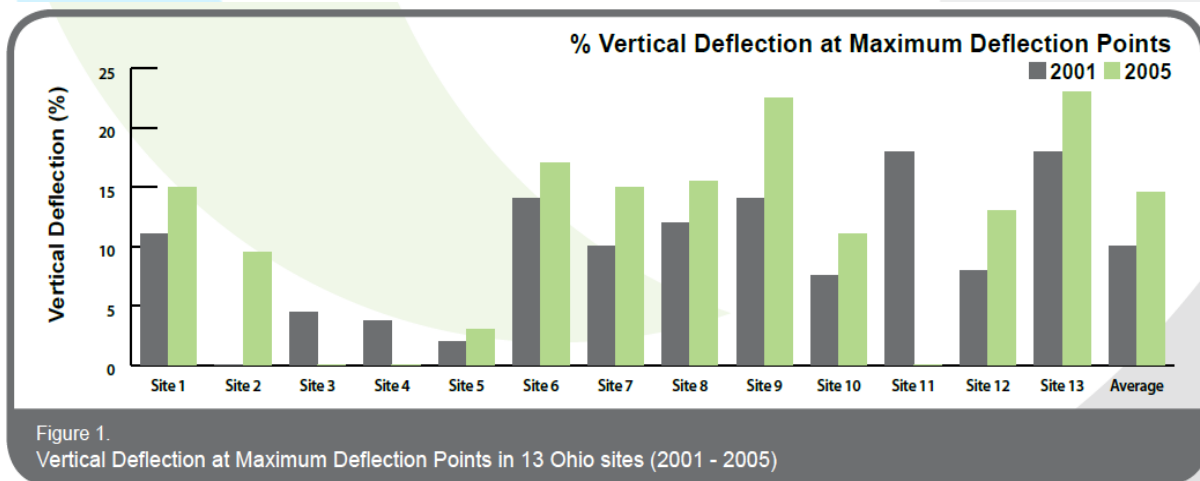
Plastic pipe deformation can be progressive: a report by Kentucky Department of Transport, USA, demonstrates the case of a pipeline network installed in 1989/1990 with minor deflections (<5%) in its 24 inch pipe sections. The pipeline was inspected again in 2002 and was found to be deflected by 11%, and later in 2005 by 14%. Another investigation in Ohio showed similar levels as shown in Figure 1. Deformation of plastic pipes can also become permanent, as noted by prCEN/TS 15223: 2007.

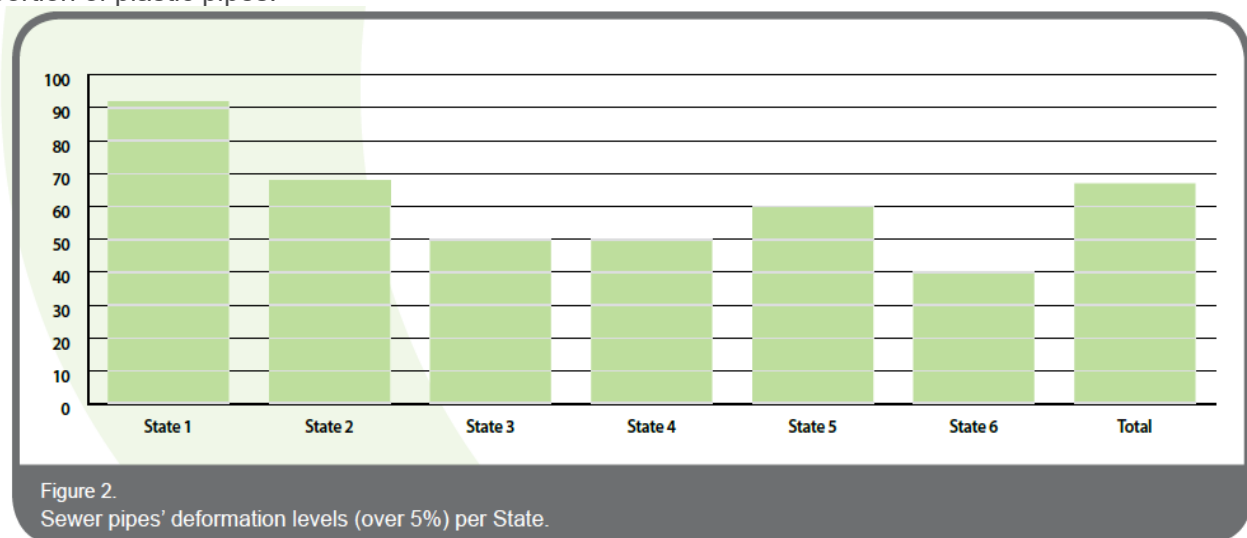
There are some indications that the deformation problem may be bigger and more significant than many would expect. A number of investigations and case studies in the last few years have highlighted the scale of the problem, and the case studies (demonstrated below) indicate that deformation may be affecting a huge proportion of plastic pipes:

Condition grading study in six US States: A study survey was carried out in 2002 to investigate levels of deformation in plastic pipe networks installed since 1987 in six American states. The results were significantly alarming and showed what could be the real scale of the problem in these states as 69% of the pipes inspected had deflections exceeding 5%.

Kentucky and Ohio Departments of Transport investigations: These two investigations looked at over 1.18 km of HDPE pipeline systems. It was found that the majority of pipes investigated would not pass a 5% deflection test and most of the sites inspected have pipe sections that would not pass a 10% deformation test.

Texas University at Arlington research: The structural performance of 22 HDPE pipelines throughout the State of Texas was investigated. 38% of the pipelines inspected had excessive deformation (over 5%). The average deformation value for all pipes was found to be 6.8%. The study clearly indicated that the structural health and integrity of the installed HDPE pipelines tested are generally below structurally acceptable levels of serviceability.
